BOURLAND TRESTLE HISTORIC PRESERVATION OPTIONS

HISTORIC PRESERVATION OPTIONS
FOR THE

BOURLAND TRESTLE
IN THE
STANISLAUS NATIONAL
FOREST

January 5, 2000

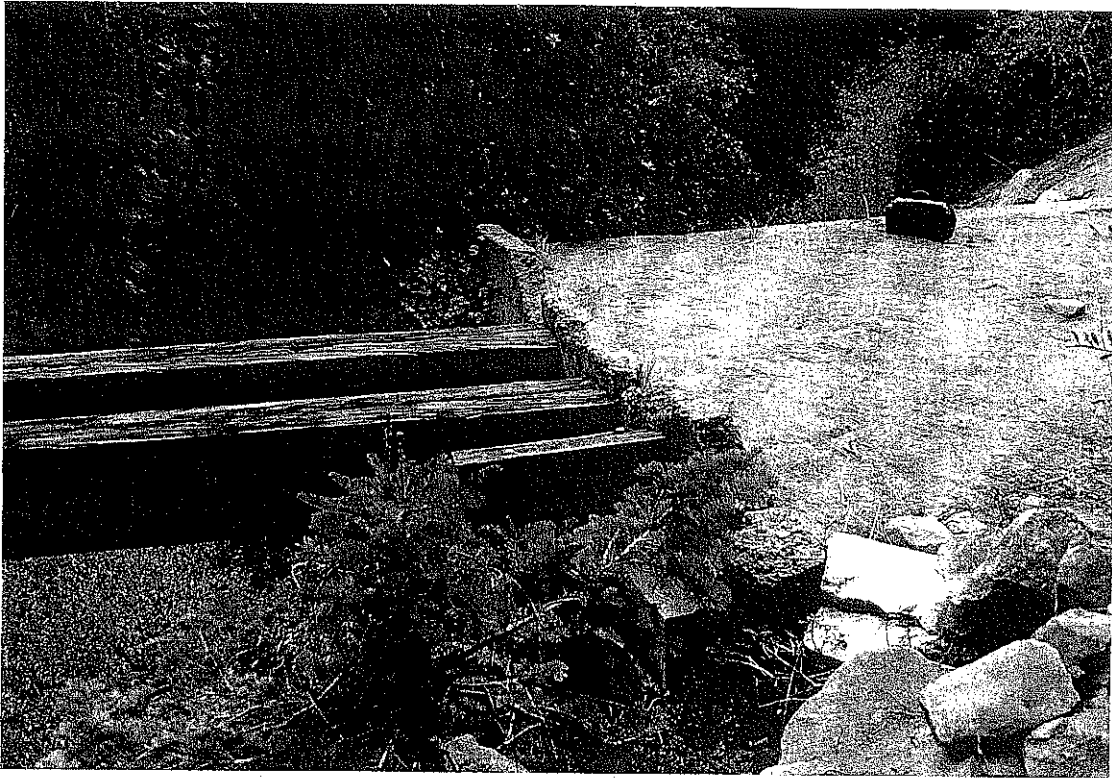
Landing @ # 0

Concrete is in good shape but the ledger needs some repairing.

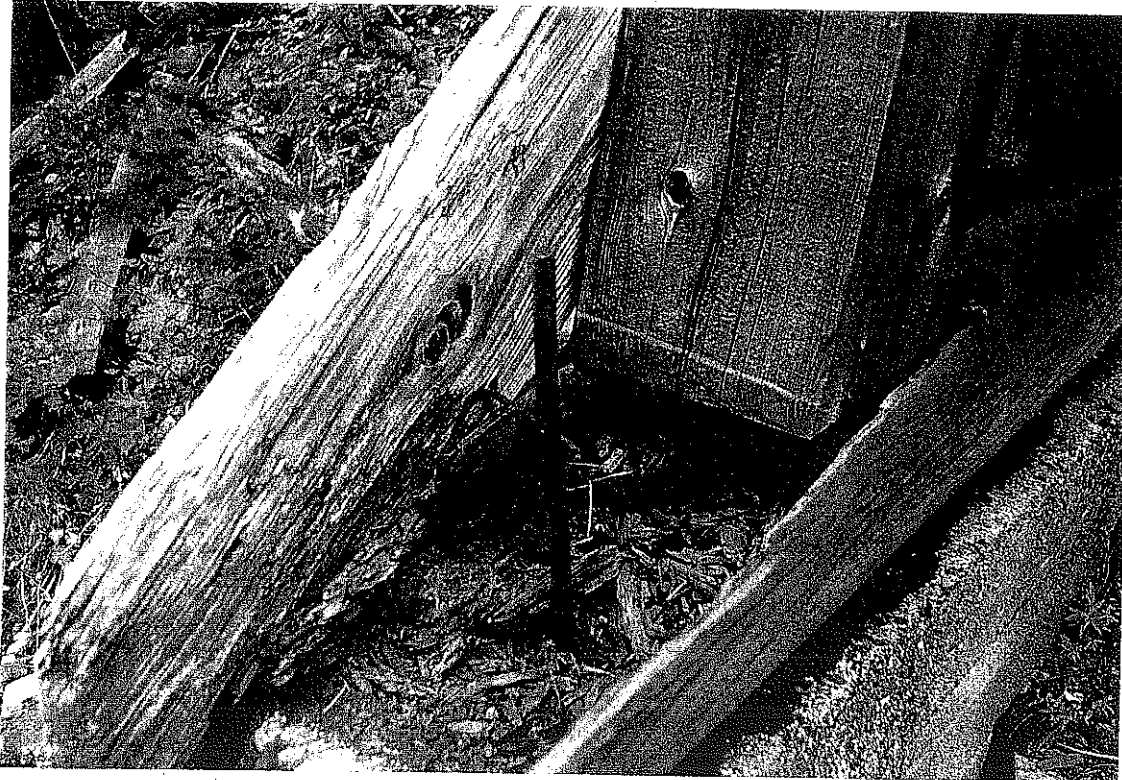
Sill dry rot with bolt coming through,
not holding anything anymore

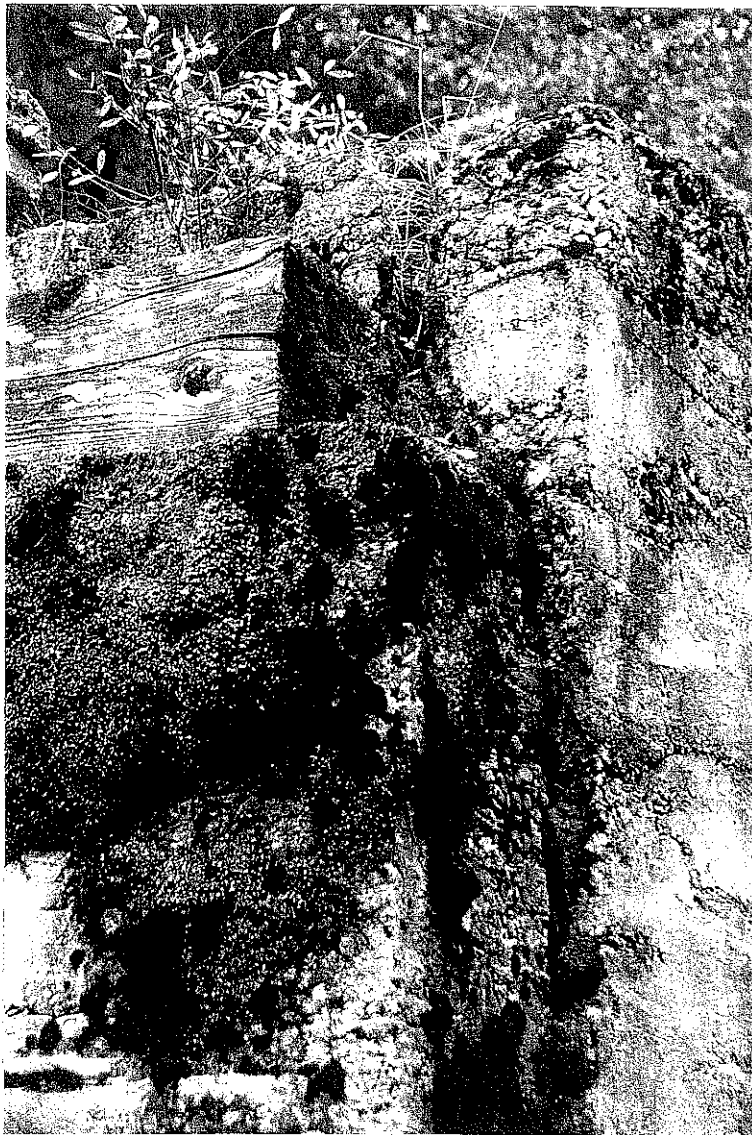
Landing @ # 23 shows vertical crack in concrete

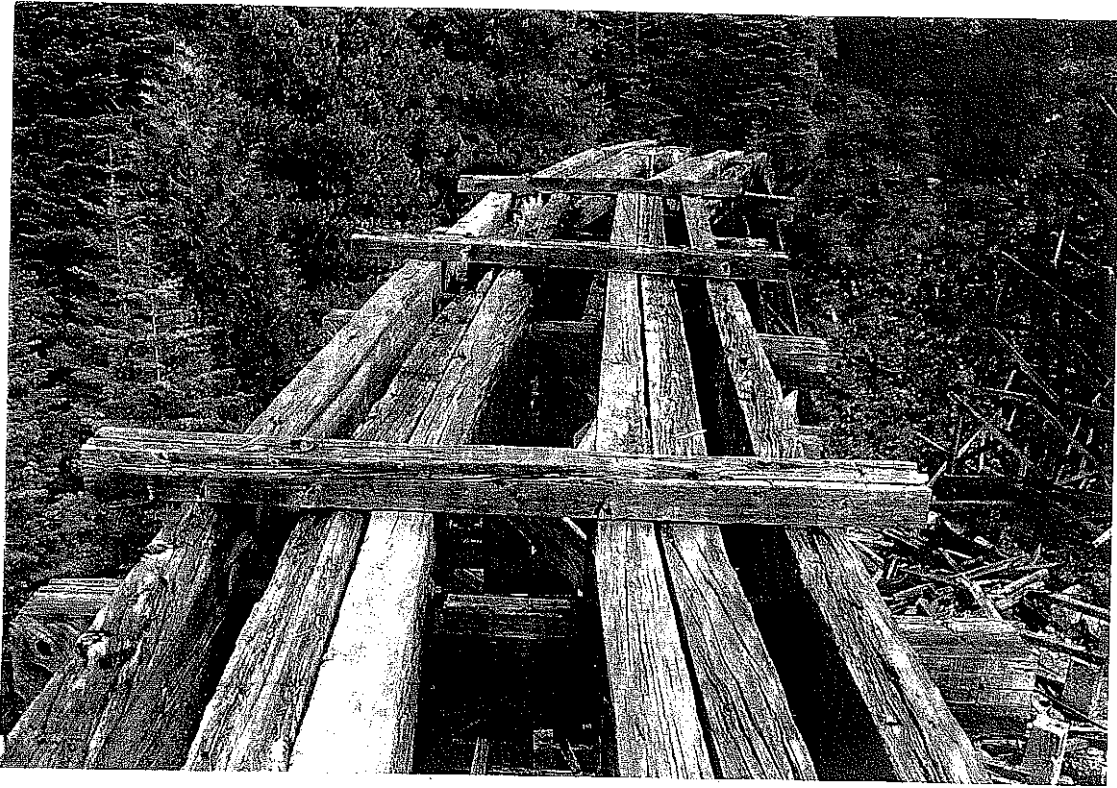
Dry rot shown on tops of stringers,
heavy damage shown on stringer #1

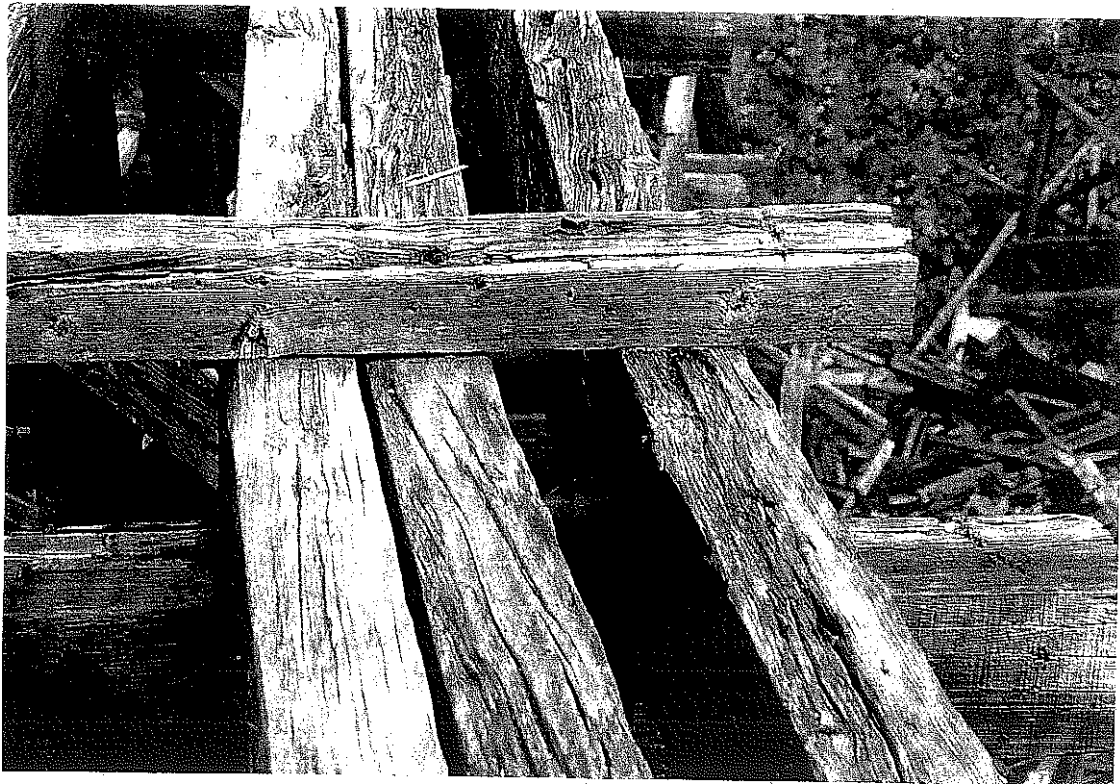
Railroad tie showing some damage and cast iron
hardware between the stringers

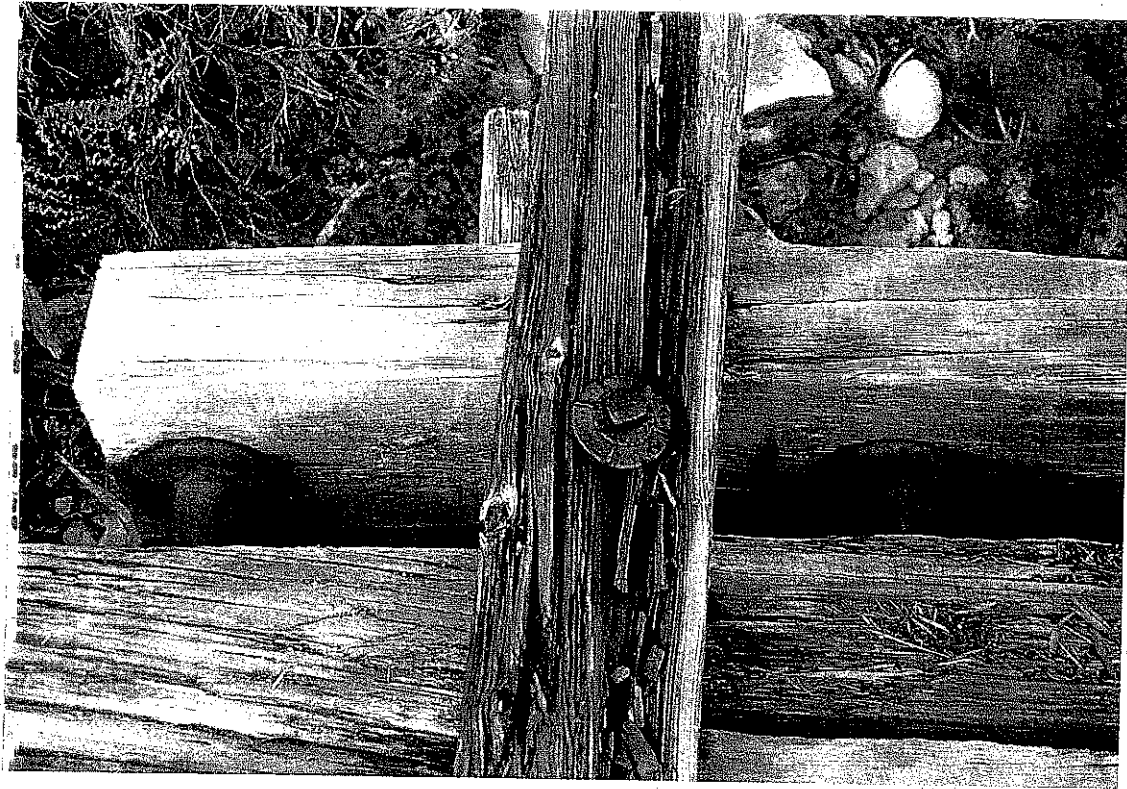
Dry rot, cast iron hardware, and bolted connection
