RE: The Rim Fire – Hetch Hetchy Watershed Effects Report

Rim Fire – Hetch Hetchy Watershed Effects

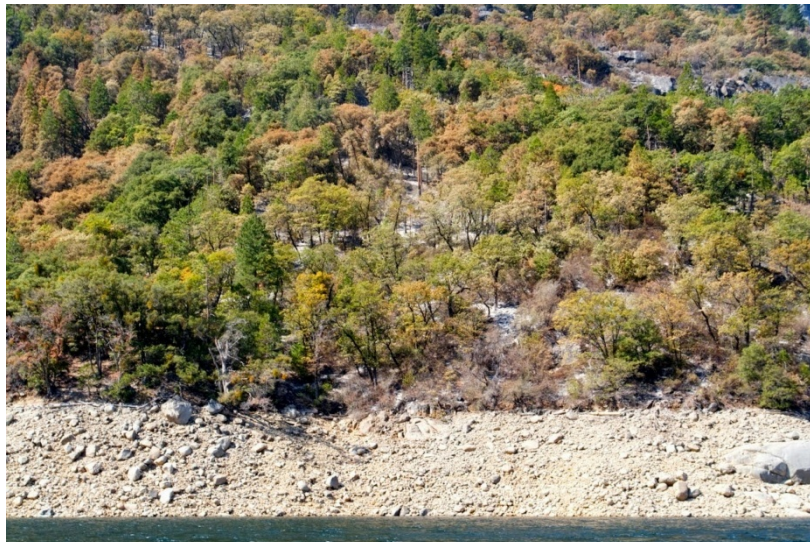
The SFPUC team made five trips to Hetch Hetchy Reservoir to observe fire conditions, extent, and severity (August 30, September 5, September 11, September 25 and September 26). These site visits are described in detail in Appendices 4, 5, 6 and 7. Active fire conditions were observed during the initial site visits on August 30 and September 5th. The fires were described as spotty and active mainly in the understory, burning ground duff and dead, downed debris. As the fire progressed, understory burn became more widespread especially in areas on the south shore east of Kolana Rock. The overstory canopy was not greatly affected along the south shore area (Figure 3).

Figure 3: Understory burn along the south shore of the reservoir (September 17, 2013).

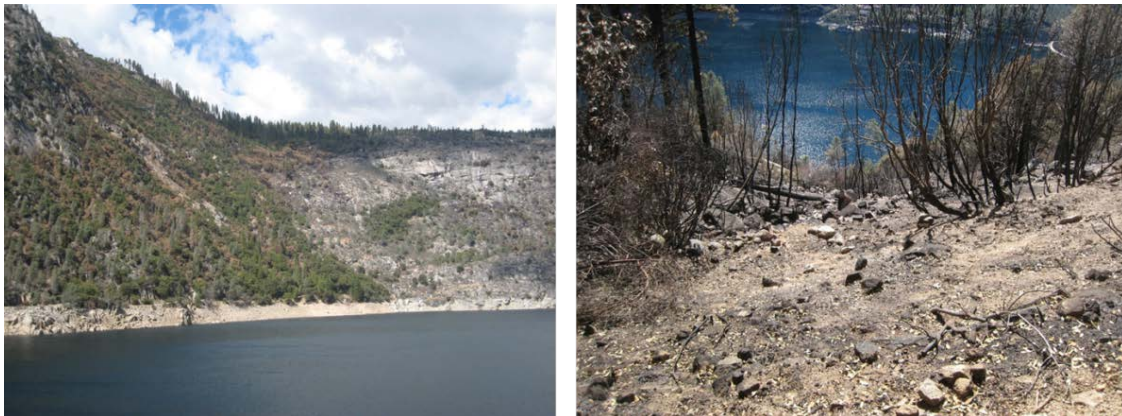
The BAER burn severity map describes the area within the Hetch Hetchy watershed as a total of 5,080 acres, with 70% within the unburned/very low, 23% low, 6% moderate, and 1% high. Misclassification is not uncommon in the BAER burn severity mapping due to the infeasibility in field validating remotely sensed data at all locations. Field observations suggest that the overall burn severity was lower than that identified in the BAER team analyses.

Figure 4: Isolated high burn intensity slope on the north side of Hetch Hetchy Reservoir

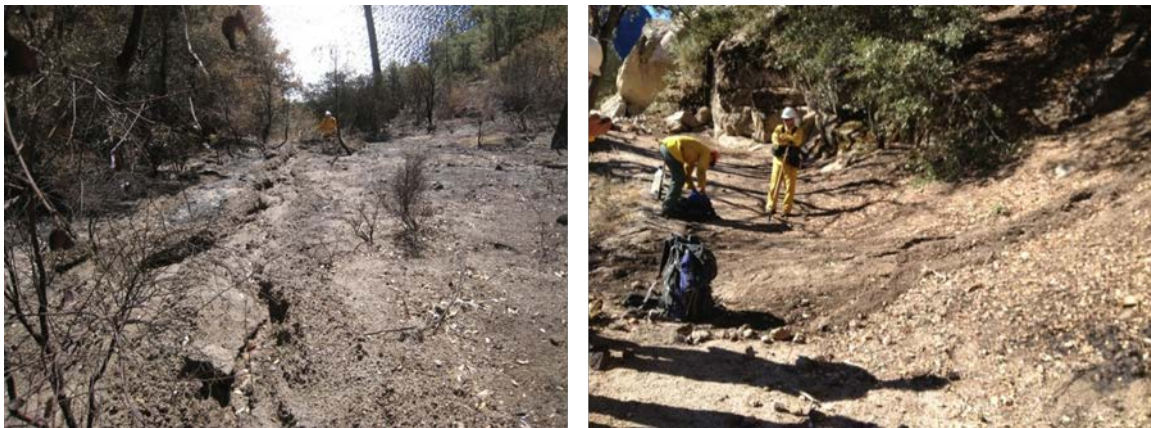
(Figure 5) was noted on slopes on both aspects due to the September 21st rain event. The rills were initiated at the toe of exposed granite outcrops which contributed surface flow to the upper portion of the soil covered slopes. The flow contribution rate from the granite outcrop exceeded the soil infiltration rates, likely exacerbated by fire induced decreases in soil infiltration rates and increased soil hydrophobicity. The rills did not appear to accumulate additional water downslope as indicated by the lack of rill expansion. The rills were incised 4 to 6 inches and the majority of the material was pushed laterally rather than down slope. The resulting sediment deposits were 5 to 10 cubic feet of material at the base of the hillslope. The lack of observed historical rill scars indicates that the fire conditions may have contributed to the rill formations. The areas around the reservoir with the potential to have rilling is minimal due to the unique topographic features and position necessary to generate concentrated surface runoff to fire affected hillslopes.

Figure 5: Rill formation (left) on the North side of Hetch Hetchy and subsequent sediment deposit (right) on the Beehive/Vernon Lake trail.

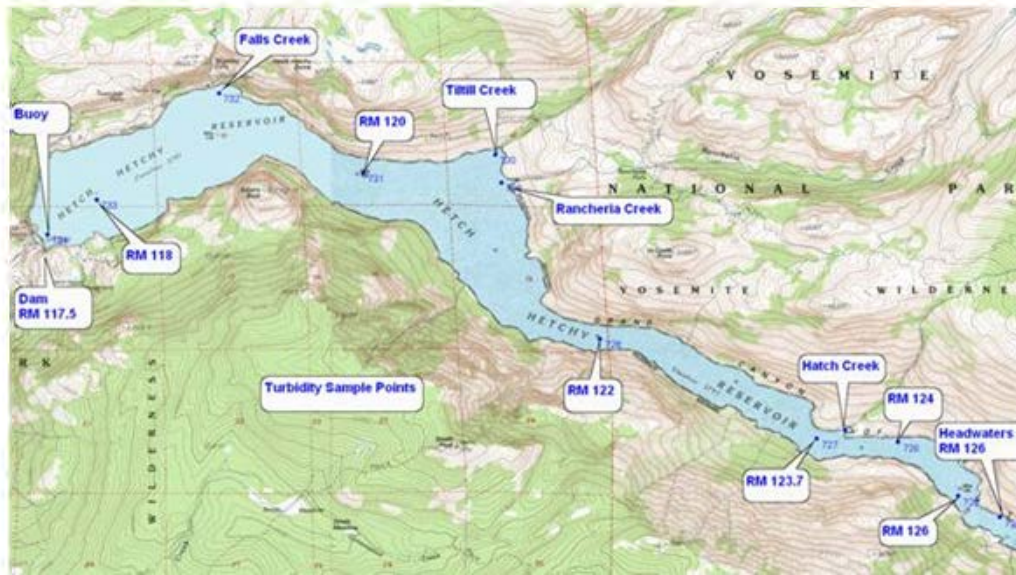
Figure 6: Sampling locations

Staff was able to access the reservoir beginning August 30th (Appendix 9). Supplemental reservoir monitoring occurred on September 5th, September 11th and September 25th. The monitoring locations are shown in Figure 6.

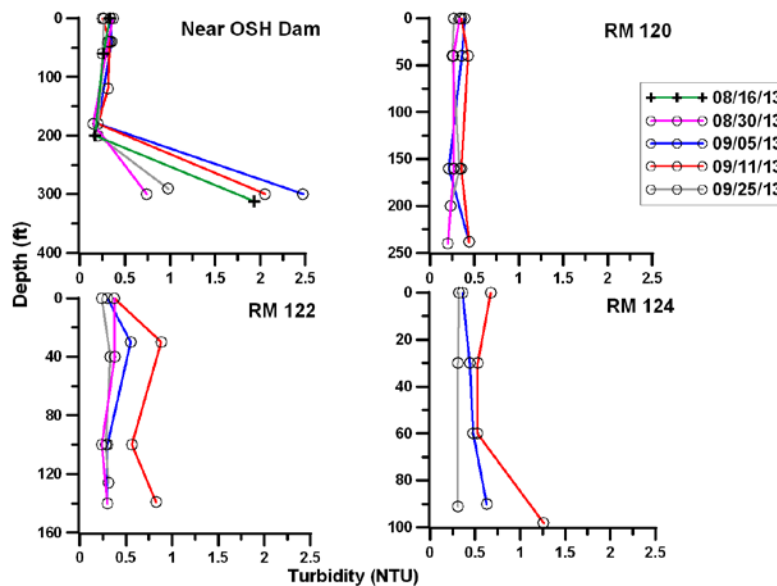
Limnological profiles were completed near the Dam and River Miles 120, 122 and 124. Observations of conditions prior to the fire indicated seasonally increasing anoxic conditions at depth in the reservoir so this condition is not attributed to the Rim Fire. The measurements prior to and during the fire, indicate no change in the water quality conditions of the reservoir. Turbidity at Priest Reservoir monitored by SCADA throughout the event remained unaffected and in the normal operating range.

Figure 7: Turbidity profiles in Hetch Hetchy Reservoir prior to and during the Rim Fire.

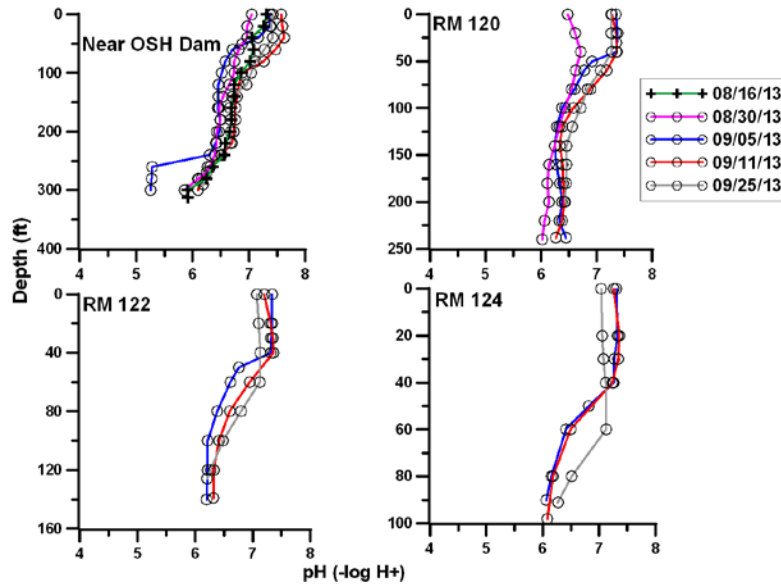
Limnology profile observations (Appendix 11) include depth profiles using an YSI sonde which measures water temperature, pH, specific conductivity, total dissolved solids, dissolved oxygen, and oxidation reduction potential. Grab samples to measure turbidity were also made at the surface, in the epilimnion, in the hypolimnion and near the bottom of the reservoir. Of the data collected of specific interest is the turbidity, as an indication of any change due to ash or sediment deposition in the lake (Figure 7). The pH measurement is an indication of increased ash (Hetch Hetchy water has very low alkalinity and ash leachate would increase pH) (Figure 8).

Figure 8: pH profiles in Hetch Hetchy Reservoir prior to and during the Rim Fire.

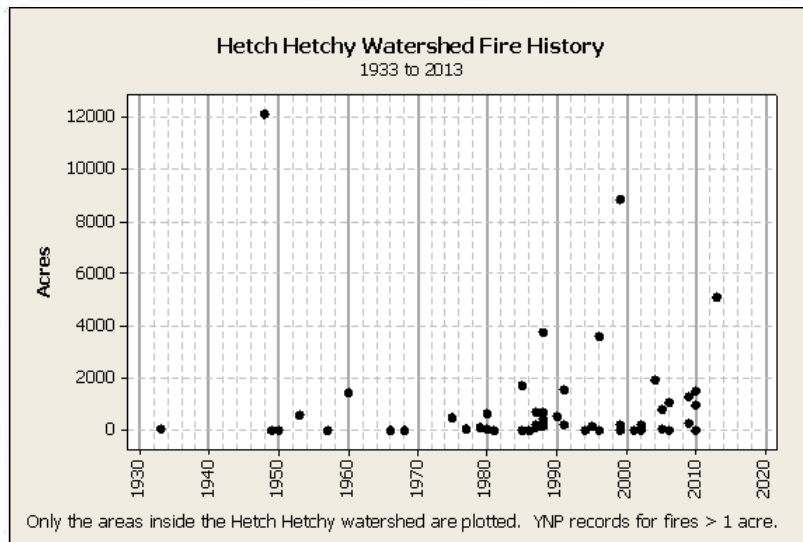
Wildland fire has an active history in the Hetch Hetchy watershed, with typically at least one fire occurring every year in or on the periphery of the watershed. Historical fires vary vastly in size from isolated ignition of down debris or trees due to lightning to the largest recorded fire of 12,116 acres – the 1948 Rancheria Fire (which was human caused). Recent fire history was reviewed by the Water Quality Division in 2010 (Appendix 13) and updated by the Watershed Forester (Appendix 4). Table 7 below summarizes the fires in the watershed greater than 1,000 acres. The recorded fire history since 1931 identifies 32 fires with areas greater than 100 acres and 28 fires between 10 and 100 acres. Annual total area affected by fire is typically low, compared to the 287,000 acres of the Hetch Hetchy drainage (Figure 9).

Figure 9: Recorded fires greater than 1 acre Hetch Hetchy Watershed.

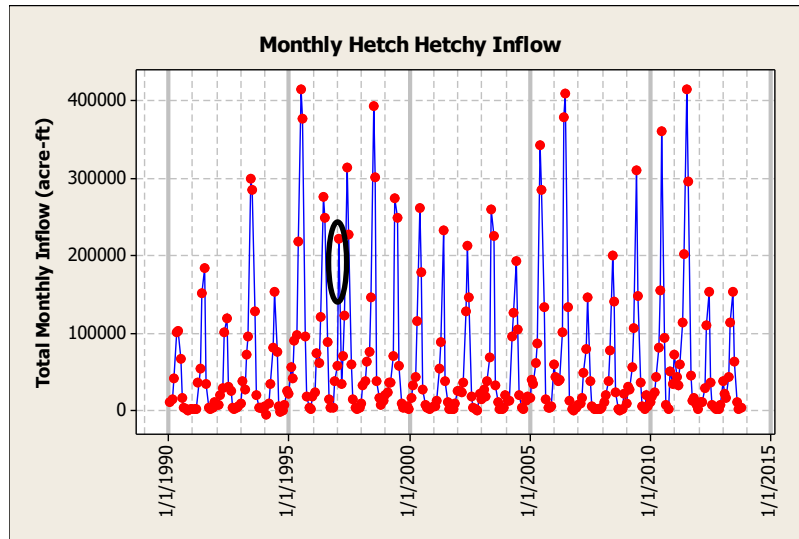
Figure 11: Time series of inflows into the Hetch Hetchy Watershed. Note: circle shows the January 1997 storm.

The second event was a large rain-on-snow event driven by an “Atmospheric River” (or Pineapple Express) on December 30, 1996 thru January 6, 1997 (9.59 inches of precipitation in a 5 day period) which resulted in a 100 year flow event at Hetch Hetchy Reservoir. This high flow event resulted in turbidities in the reservoir exceeding 5 NTU and the delivery of Hetch Hetchy water was interrupted for a sustained period. The turbidity was above 5 NTU from January 3rd through January 10th. Turbidity remained above 2 NTU until January 29th and fell below 1 NTU on March 7th.

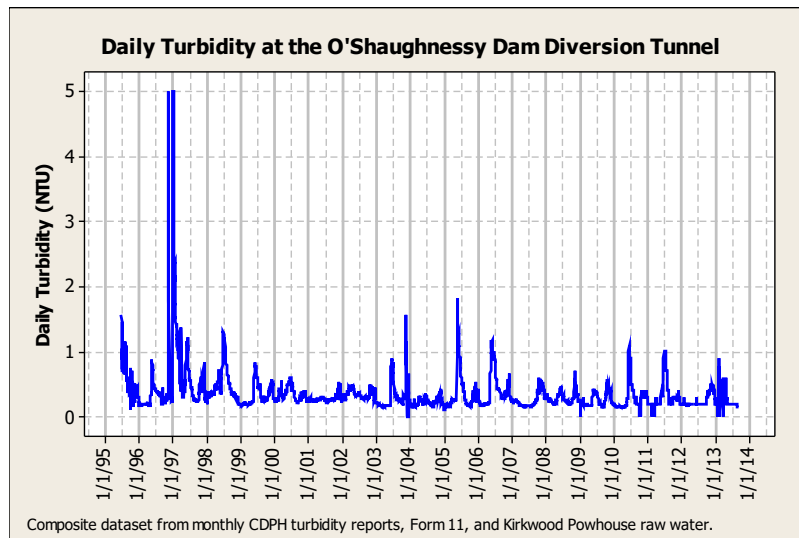
Figure 12: Time series of daily average turbidity, as measured at the O'Shaughnessy diversion tunnel.

The water turbidity at the O’Shaughnessy Diversion Tunnel is typically measured in the range of 0.15 to 0.5 NTU. The turbidity varies seasonally based on limnological conditions (such as anoxic conditions and seasonal reservoir turnover) and runoff and storm effects (Figure 11 and Figure 12). During higher snowmelt runoff periods, turbidity may increase but has not exceeded 1.6 NTU (Table 8). Fall and winter storm events with significant flows can generate increases in turbidity.

Two events in the historical turbidity record (archives available since July, 1995) have interrupted the delivery of Hetch Hetchy water to the water supply system (Figure 12). The first was two fall storms over an 8 day period (9.35 inches of precipitation) in November 1996 which resulted in a brief, but significant, increase in turbidity as measured at the O’Shaughnessy Diversion Tunnel. The reported peak turbidity was near 20 NTU. Turbidity conditions quickly decreased and turbidity exceeded 2 NTU for only two days.
