BOURLAND TRESTLE HISTORIC PRESERVATION OPTIONS

HISTORIC PRESERVATION OPTIONS
FOR THE

BOURLAND TRESTLE
IN THE
STANISLAUS NATIONAL
FOREST

January 5, 2000

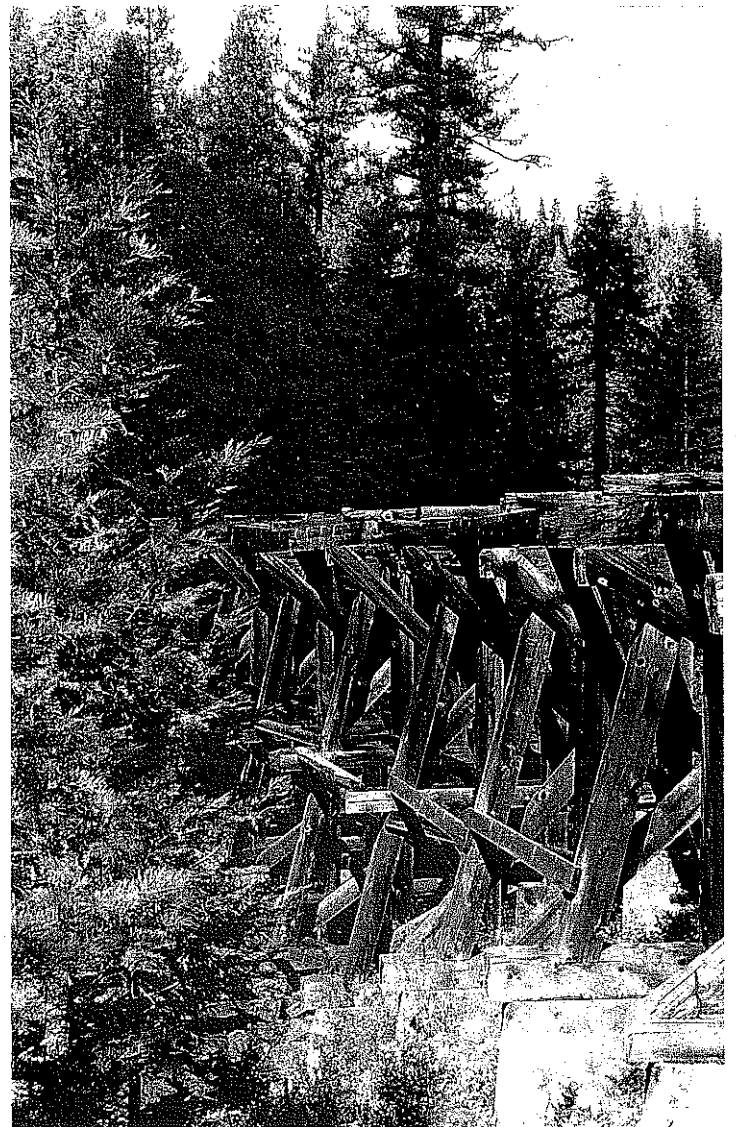
LANDING AT #23

Landing @ # 23 shows vertical crack in concrete

The cap is dry rotted and crushing and must be replaced. The #4 and #6 Stringers are gone and must be reinstalled. Stringers #1, #2, #3 and #5 are all fixable. The concrete landing wall has a vertical crack at the connection on the downstream side of the two perpendicular concrete walls. It should be reevaluated. (Stringers from Bent #22 to the landing at #23).
